# Manhole Inspection Summary

Manhole # S45E\_\_021MH

Insp Date: **7/23/08 9:57 AM**

**Location** Address: **1801 baltime lombard**

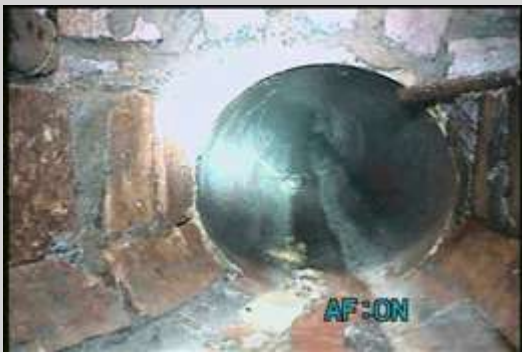
12 O'Clock Outflow

8 in. Circular Gravity Sewer  
Pipe Out @ 12 O'Clock

Invert Depth: 9.30 (ft.) Flow Characteristics: **Fast**

Deposits: ☒ None ☐ Mud ☐ Sludge ☐ Debris ☐ Grease

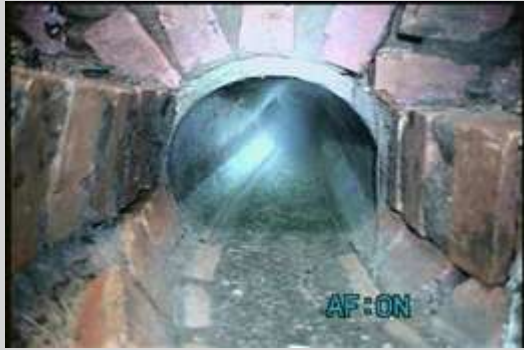
9 O'Clock Inflow

8 in. Circular Gravity Sewer

Pipe In @ 9 O'Clock
